# SEM-EDS

## ADVANCED WEAR DEBRIS ANALYSIS FOR OPTIMIZED MAINTENANCE

AUTOMATED SEM-EDS ANALYSIS FOR ROUTINE  
CONDITION MONITORING

# ADVANCED WEAR DEBRIS ANALYSIS FOR OPTIMIZED MAINTENANCE

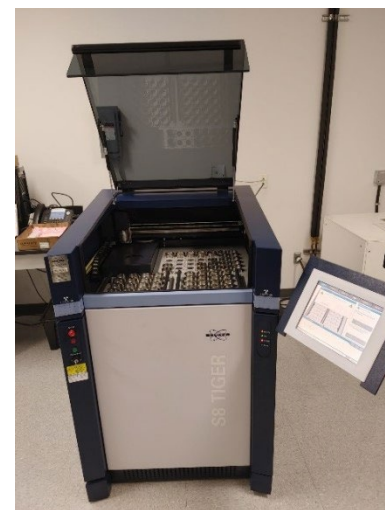
Figure 2. WDXRF Spectrometer used for analysis of Oils and Filter. Source: Fluid Life.

**XRF Spectrometry** can detect these larger particles and has been used for decades to analyze wear debris in oil and fuels. Modern EDXRF or WDXRF instruments (Figure 2) can analyze samples of lubricants taken directly from a piece of equipment as well as filter patches prepared from filters and magnetic plug debris. XRF analysis has been shown to detect failure modes involving large particles missed by ICP Spectrometry. These studies relied on detailed knowledge of the metallurgy and maintenance histories of the equipment to determine the sources of wear metals. This limited applying the methodology to routine condition monitoring as it is simply not practical to know the metallurgy of every component.
