ANALYTICAL FERROGRAPHY

Ferrography provides a detailed “forensic science” analysis of the wear particles, contaminants and lubrication degradation, by interpreting the debris on a ferrography slide. By analyzing the color, morphology, size, and surface detail of ferrous and nonferrous wear particles, an experienced analyst can provide accurate information about the type, severity and root cause of normal and abnormal wear.

PARTICLE IDENTIFICATION

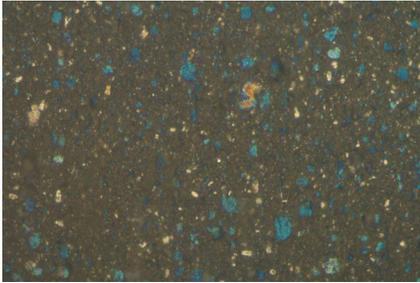
Normal Rubbing/Sliding Wear

- <15 microns in size
- Little or no visible texture to particles
- Due to normal rubbing/sliding of metal surfaces against each other

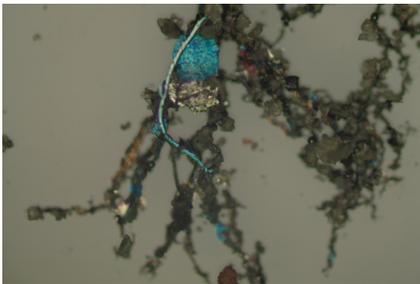
Cutting Wear

- Long curved or corkscrew like particles
- May be due to one surface contacting another (two body wear), or an embedded particle in one surface contacting another (three body wear)
- May also be an indication of misalignment
- Presence is always abnormal

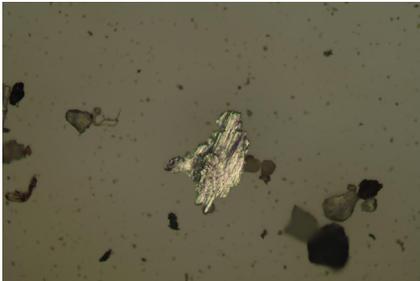
Adhesive Wear

- Particles are 'three-dimensional' in shape (not flat)
- Generated when two metal surfaces contact each other under a compressive load and experience plastic deformation (surfaces are temporarily welded together, and material from one surface is transferred from the first surface to the second surface).
- Includes sliding wear

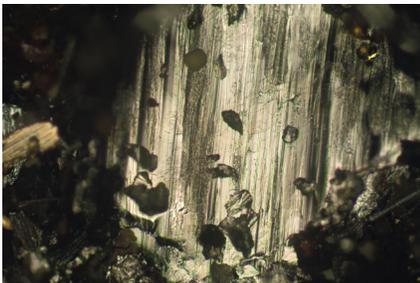
Severe Sliding Wear

- >15 microns in size
- Large particles showing parallel striations along the surface
- Generated due to excessive loads and/or speeds on a sliding surface
- Presence is always abnormal

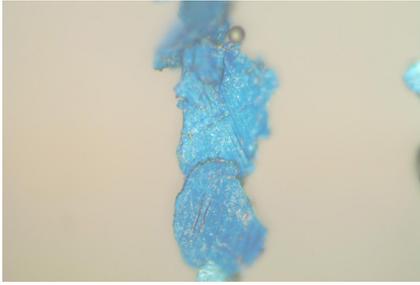
Laminar Wear

- Particles >50 microns in size, with smooth flat surfaces
- Particles are 5-50 times longer than wide
- Result of fatigue wear generated in rolling element bearings (micro-spalling) that has been flattened in the rolling contact zone

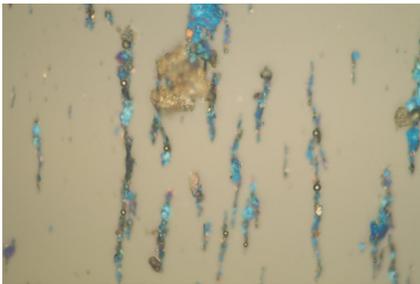
Spheres (large diameter and small diameter)

- Symptom of fatigue or outside contamination
- May also indicate static electrical discharges or the melting of babbitt bearing surfaces due to friction
- Spheres <5 microns in size may be wear particles associated with rolling element bearings
- Spheres >5 microns in size are likely due to cavitation or contamination (grinding, welding, sandblasting or flash)

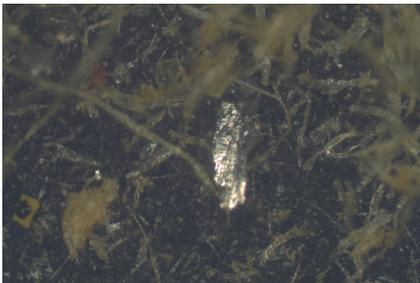
Fibers/Cellulose

- Appear as long, tubular white/gray particles
- Two sources:
 - External contamination (Rags, shop cloths, coveralls) or
 - Internal component generation (Filter material, Clutch plates)
- May be an indication of clutch plate wear or filter failure

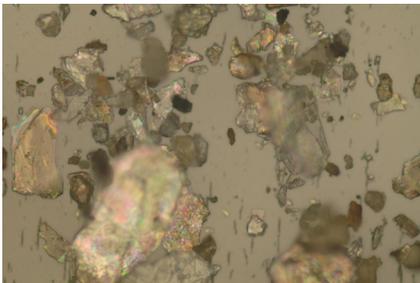
Dirt/Dust/Sand

- Particles are typically opaque or mottled in appearance
- Result of airborne contamination ingested by equipment due to faulty seals, breathers, or poor maintenance practices
- May also be due to contaminated new oil (unclean barrels/tanks, transfer containers)

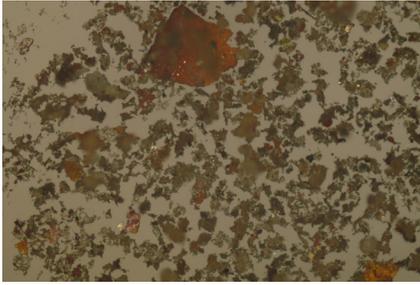
Red Oxides (Rust)

- Orange or brown colored particles
- Generated from rust, or as a result of corrosion/oxidation of iron parts
- Most likely cause is water contamination

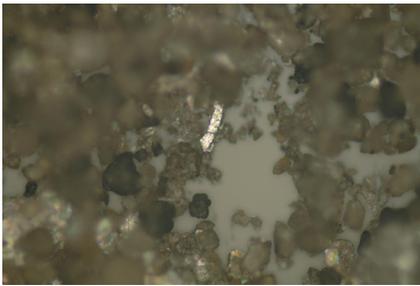
Dark Metallo Oxides

- Dark grey or black particles
- Indication of high operating temperatures due to insufficient lubrication

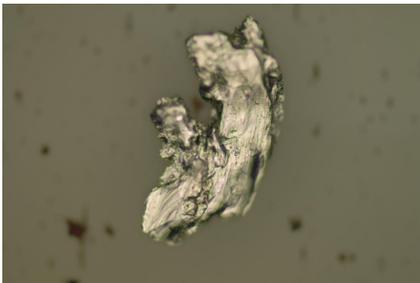
Aluminum

- White metal particle
- Indicates that aluminum components are wearing

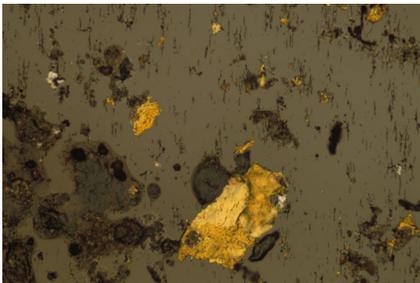
Copper/Copper Alloy

- Yellowish/gold particles
- Indicate that copper/copper alloy (brass/bronze) components are wearing

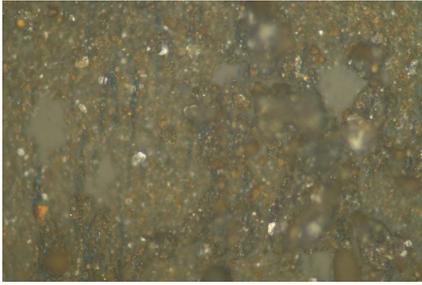
Inorganic Debris

- Other metallic particles where the metal cannot be identified

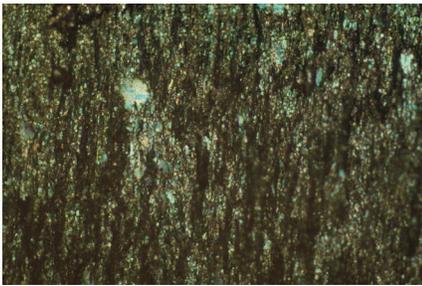
Organic Debris

- Can appear as dark streaks (like slime) caused by oxidation by-products (sludge, etc.)
- Can appear as small black particles (carbon) caused by combustion by-products (soot) or solid lubricants (graphite, teflon)
